Fred Gerber Deputy Director, Enfield Public Works Re: Mold and Indoor Air Quality Results Enfield High School December 6, 2023

Baseline Indoor Air Quality Report For

Enfield High School 1264 Enfield Street Enfield, CT 06082

EnviroMed Project # IH-23-1377

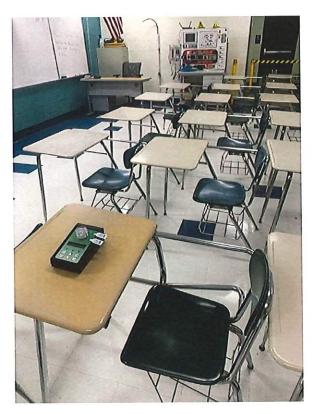
Significantly high levels of *Cladosporium* were present in this sample. Spore counts and volumes indicated a source of fungal amplification of this genus in this location.

- On Day 1, LL. Automotive Classroom was found to contain significant amplification of Cladosporium. These noted molds were not detected in any other sample locations during the testing period.
 - This represents an unacceptable finding requiring mold remediation of this area in the school facility.
- The detected formaldehyde concentrations were well below the OSHA PEL of 0.75 ppm.

Figure 1. A1 Exterior Baseline (Top Left), A2 Automotive Classroom (Top Right), A3 Wing Exit Near Paring Lot (Bottom Left) and A4 E Wing Common Area (Bottom Right).

EnviroMed Services recommends that a professional remediation contractor clean all cleanable nonporous surfaces with a disinfecting agent such as Fiberlock ShockWave or equivalent in the affected area of the LL. Automotive Classroom, in addition, EnviroMed Services, Inc. recommends the use of an air scrubbing system to remove all airborne spores. We also recommend the use of a HEPA (High-Efficiency Particulate Air) vacuum. Prior to cleaning, a Negative Air Pressure Containment setup will be required to prevent the contamination of any airborne mold spores during the remediation process. Containment air to be exhausted outside containment area during remediation. The HEPA Sandwich method (vacuum/ clean/ vacuum) is recommended with the continued use of an industrial HEPA Air Unit for at least 24 hours' post abatement work to further clean the air.

Following the cleaning, EnviroMed recommends a follow-up microbial assessment be performed by a professional industrial hygienist to verify the effectiveness of the cleaning.

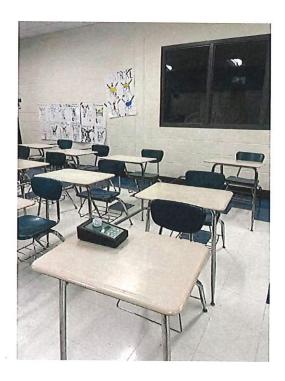
Following these findings, the E Wing Automotive Classroom was cleaned and disinfected thoroughly to eliminate any elevations of airborne mold. On November 7, 2023, EnviroMed Services conducted Clearance Air Testing in the E Wing Automotive Classroom to confirm the successful remediation of the airborne elevation. This air test revealed no elevations of Cladosporium or any other airborne mold. EnviroMed Services considers this Test a PASS and considers the space safe for student use.

- On September 18, 2023, LL. Automotive Classroom was found to contain significant amplification of Cladosporium. These noted molds were not detected in any other sample locations during that testing period.
 - This represented an unacceptable finding requiring mold remediation of this area in the school facility.
- On November 7, 2023, the airborne spore trap results inside the Automotive Classroom were overall similar to those levels and types of molds found in the outside air from the baseline.

Figure 13. Automotive Classroom and location of clearance sample A1. Figure from re-test taken on November 7, 2023.
