Fred Gerber
Deputy Director, Enfield Public Works
Re: Mold and Indoor Air Quality Results
John F. Kennedy Middle School
December 6, 2023

Baseline Indoor Air Quality Report For

John F. Kennedy Middle School
155 Raffia Road
Enfield, CT 06082

IH-23-1377

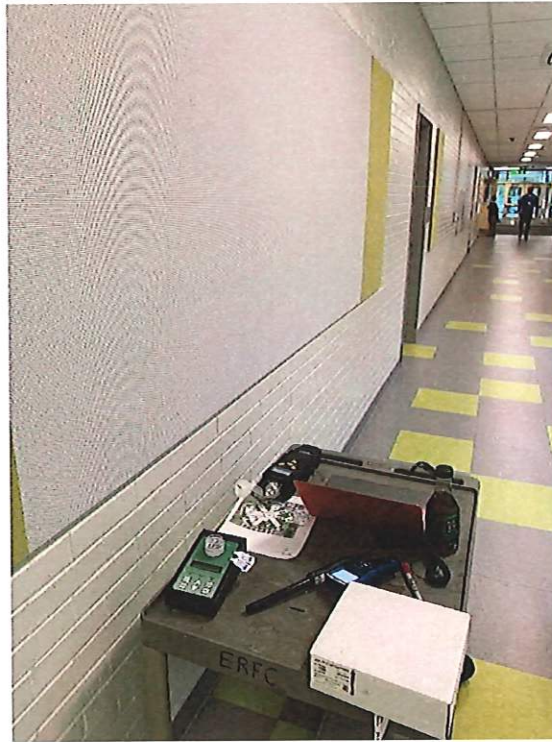
Figure 2. Location of Air Sample A2 – Green Wing Hallway

Sample ID: A2 **Sample Location: Green Wing Hallway**

Low levels of *Alternaria*, *Myxomycetes*, and *Pithomyces* were present in this sample. Spore counts and volumes were low and did not indicate a source of fungal amplification of these genera in this location.

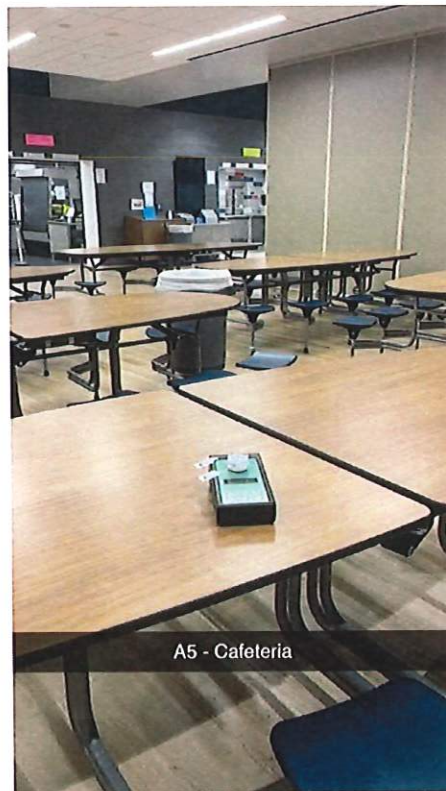
Figure 4. Location of Air Sample A5 – Cafeteria

Sample ID: A5 **Sample Location: Cafeteria**

Low levels of *Ascospores*, *Aspergillus*/*Penicillium*, *Basidiospores*, and *Cladosporium* were present in this sample. Spore counts and volumes were low and did not indicate a source of fungal amplification of these genera in this location.

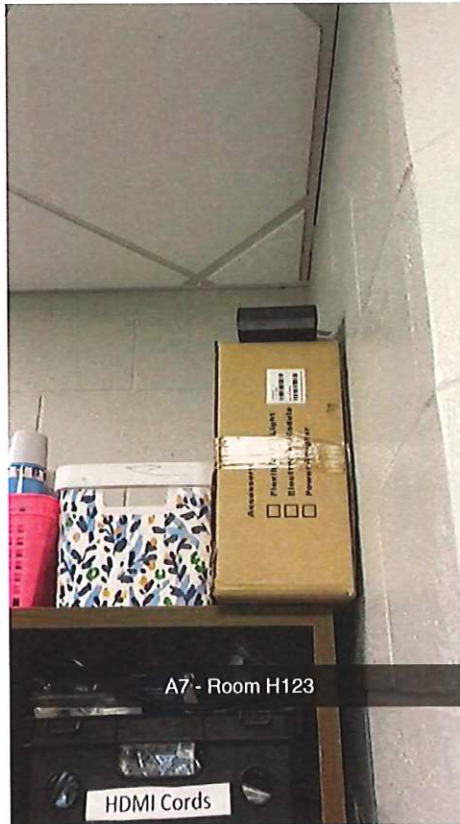
Figure 5. Location of Air Sample A7 – Room H123

Sample Location: Tech Room H123

Low levels of *Myxomycetes* and *Pithomyces* were present in this sample. Spore counts and volumes were low and did not indicate a source of fungal amplification of these genera in this location.

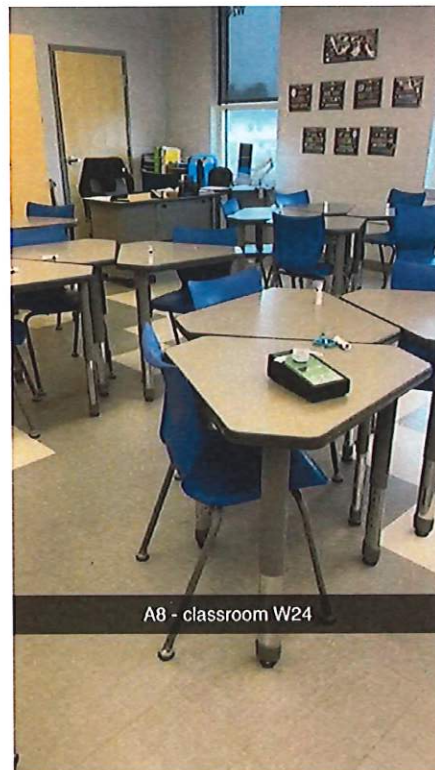
Figure 6. Location of Air Sample A8 – Classroom W24

Sample Location: Classroom W24

Low levels of *Basidiospores* and *Cladosporium* were present in this sample. Spore counts and volumes were low and did not indicate a source of fungal amplification of this genus in this location.

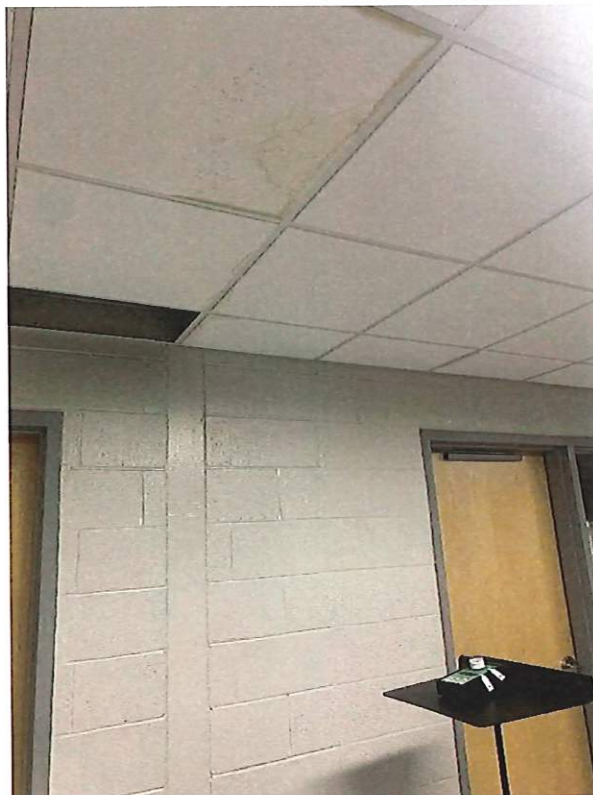
Figure 7. Location of Air Sample A9 – Hallway outside Art Room A038

Sample Location: Hallway Outside A038

Low levels of *Myxomycetes* and *Pithomyces* were present in this sample. Spore counts and volumes were low and did not indicate a source of fungal amplification of this genus in this location.

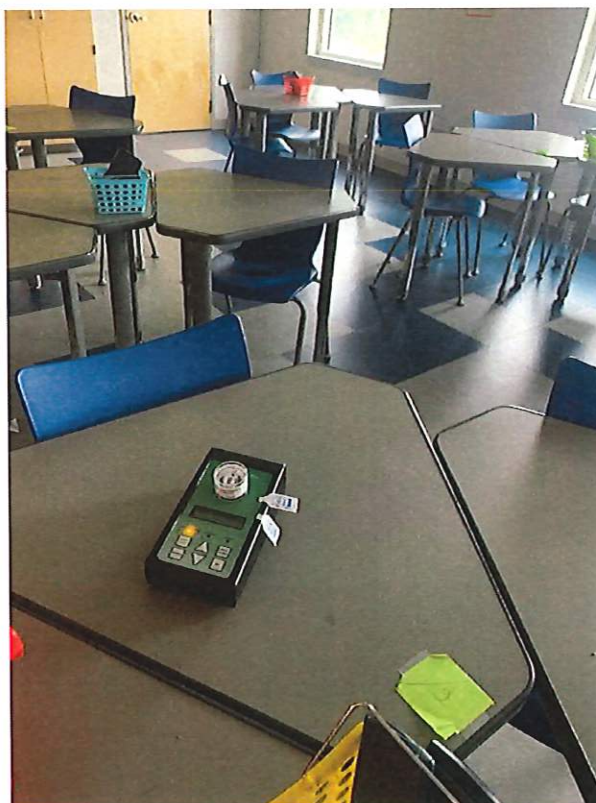
Figure 8. Location of Air Sample A10 – Classroom B22

Sample Location: Classroom B22

Low levels of *Ascospores*, *Basidiospores*, and *Cladosporium* were present in this sample. Spore counts and volumes were low and did not indicate a source of fungal amplification of these genera in this location.

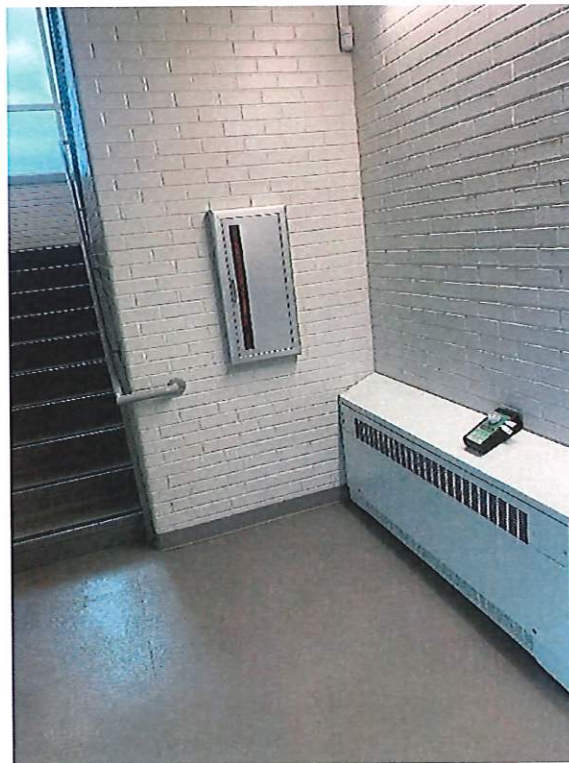
Figure 10. Location of Air Sample A12 – Stair W1

Sample Location: Stair W1

Low levels of *Ascospores* were present in this sample. Spore counts and volumes were low and did not indicate a source of fungal amplification of these genera in this location.

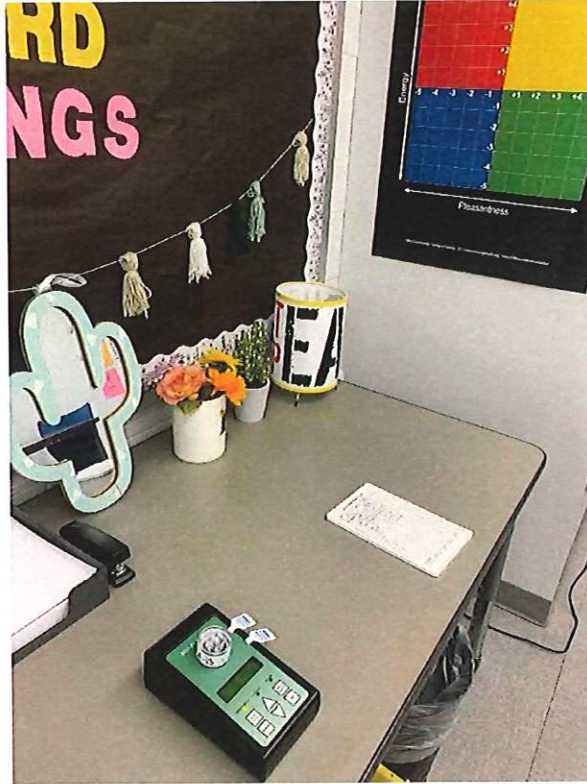
Figure 11. Location of Air Sample A13 – Classroom W22

Sample Location: Classroom W22

Low levels of *Ascospores* were present in this sample. Spore counts and volumes were low and did not indicate a source of fungal amplification of these genera in this location.

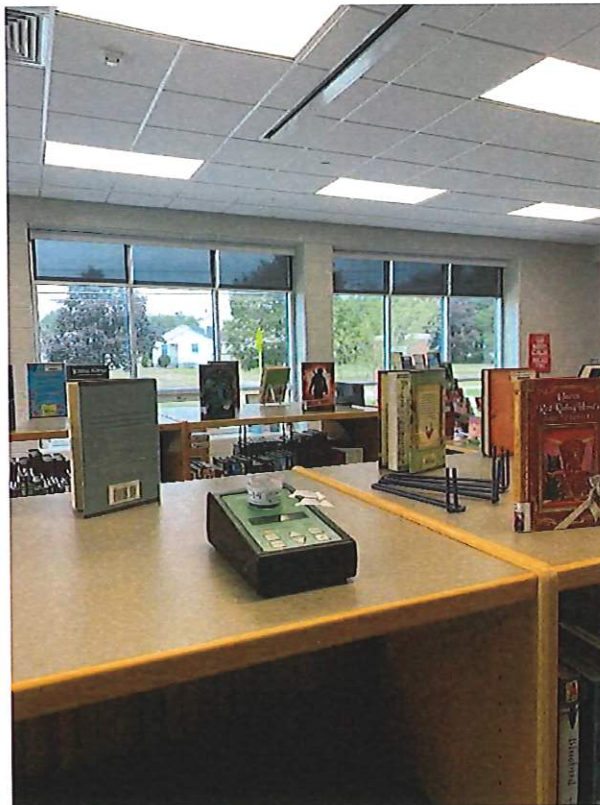
Figure 12. Location of Air Sample A14 – Library

Sample Location: Library

Low levels of *Ascospores* and *Pithomyces* were present in this sample. Spore counts and volumes were low and did not indicate a source of fungal amplification of these genera in this location.

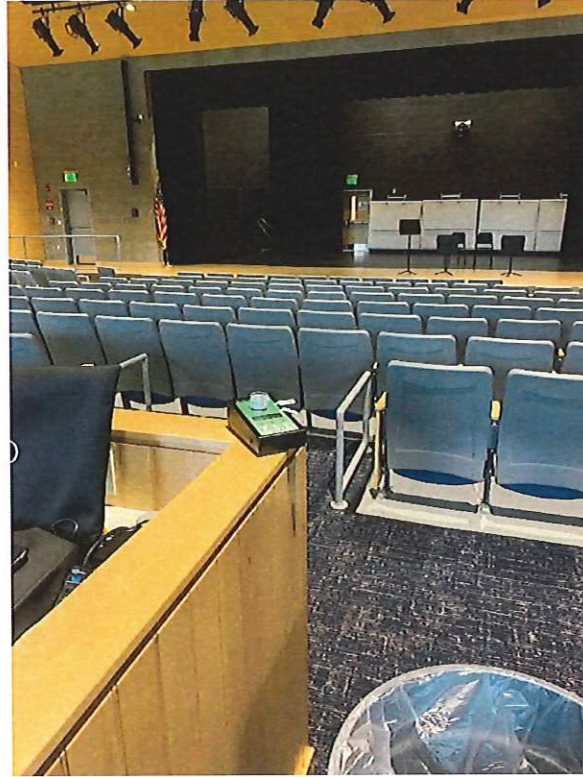
Figure 13. Location of Air Sample A15 – Auditorium

Sample ID: A15 **Sample Location: Auditorium**

Low levels of *Ascospores* were present in this sample. Spore counts and volumes were low and did not indicate a source of fungal amplification of these genera in this location.

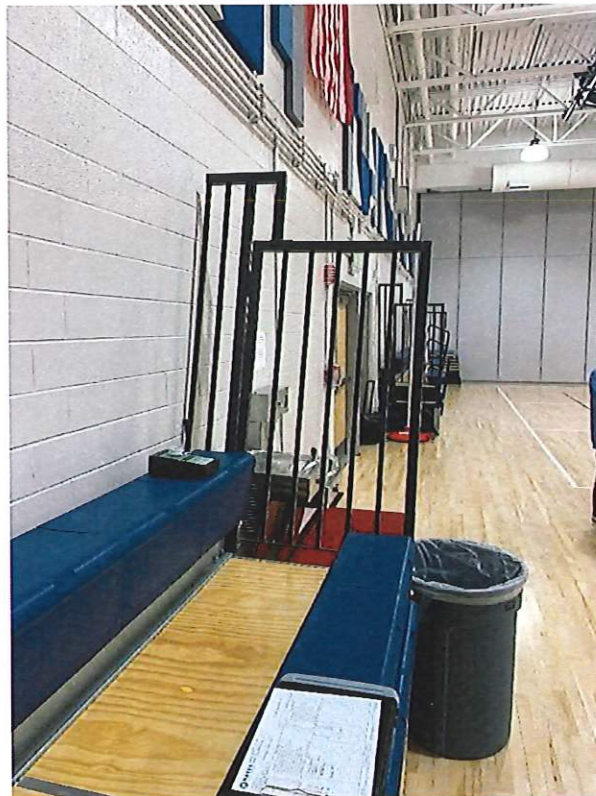
Figure 14. Location of Air Sample A16 – Gym

Sample ID: A16 **Sample Location: Gymnasium**

Low levels of *Ascospores*, *Basidiospores*, and *Pithomyces* were present in this sample. Spore counts and volumes were low and did not indicate a source of fungal amplification of these genera in this location.

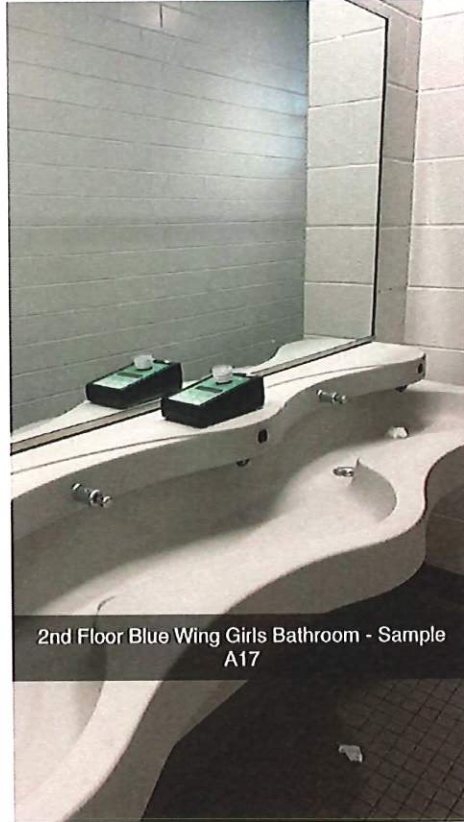
Figure 15. Location of Air Sample A17 – 2nd Floor Blue Wing Girl’s Bathroom

Sample ID: A17 **Sample Location: 2nd Floor – Blue Wing Girls Bathroom**

Low levels of *Ascospores* and *Basidiospores* were present in this sample. Spore counts and volumes were low and did not indicate a source of fungal amplification of these genera in this location.

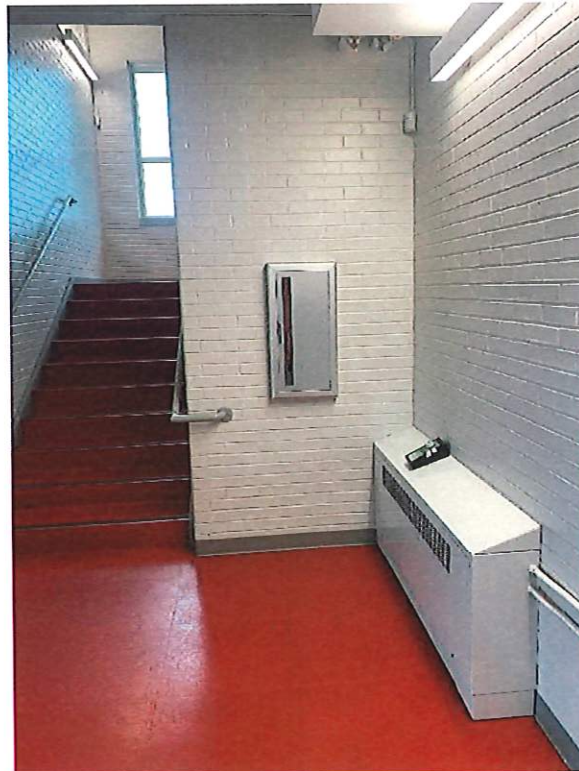
Figure 16. Location of Air Sample A18 – Stair R2

Sample ID: A18 **Sample Location: Stair R2**

Low levels of *Ascospores* and *Basidiospores* were present in this sample. Spore counts and volumes were low and did not indicate a source of fungal amplification of these genera in this location.

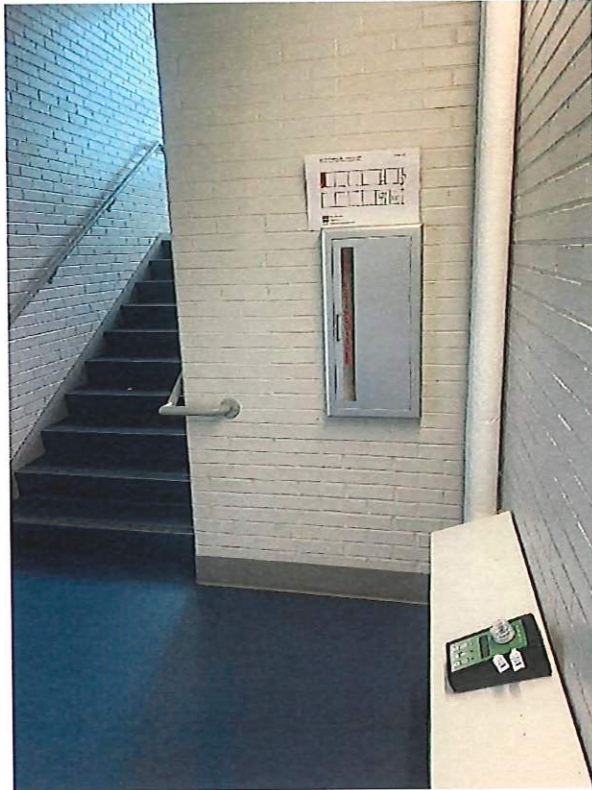
Figure 17. Location of Air Sample A19 – Stair B2

Sample ID: A19 **Sample Location: Stair B2**

Low levels of *Ascospores* were present in this sample. Spore counts and volumes were low and did not indicate a source of fungal amplification of this genus in this location.

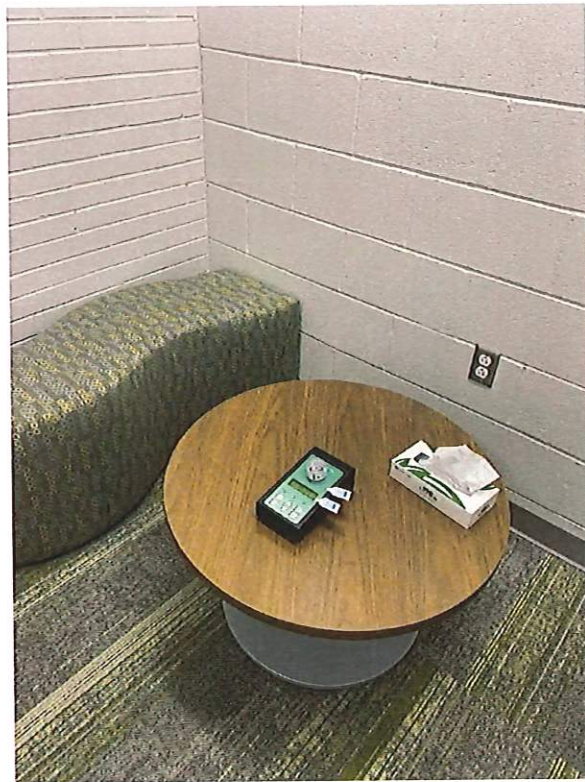
Figure 18. Location of Air Sample A20 – Main Office

Sample ID: A20 **Sample Location: Main Office**

Low levels of *Ascospores*, *Basidiospores*, and *Pithomyces* were present in this sample. Spore counts and volumes were low and did not indicate a source of fungal amplification of these genera in this location.

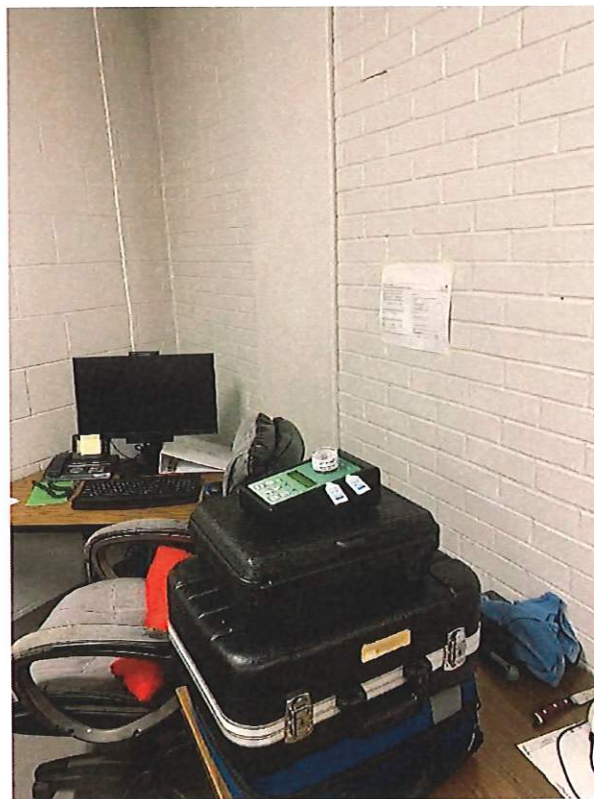
Figure 20. Location of Air Sample A31 – Custodian's Office

Sample ID: A31 **Sample Location: Custodians Office**

Low levels of *Basidiospores* were present in this sample. Spore counts and volumes were low and did not indicate a source of fungal amplification of these genera in this location.

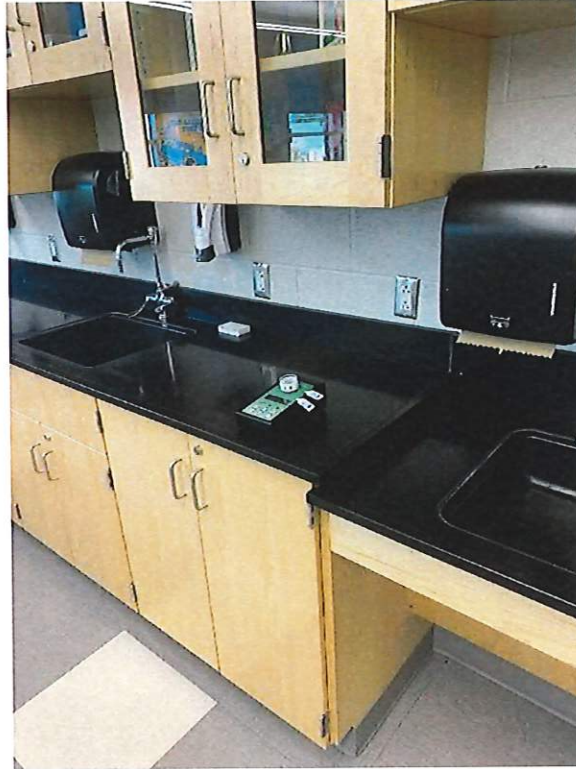
Figure 21. Location of Air Sample A32 – White Wing Classroom W21

Sample ID: A32 **Sample Location: 2nd Floor – White Wing Classroom W21**

Low levels of *Ascospores* and *Basidiospores* were present in this sample. Spore counts and volumes were low and did not indicate a source of fungal amplification of these genera in this location.

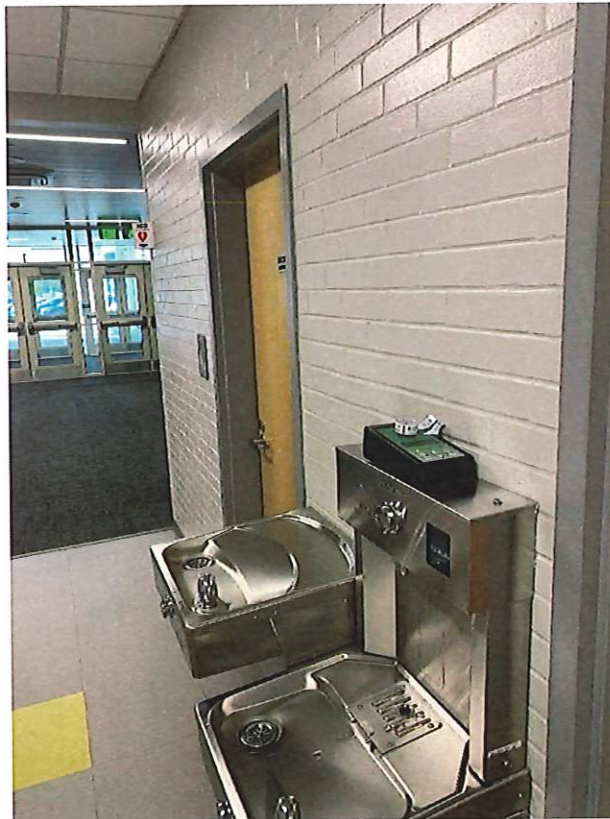
Figure 22. Location of Air Sample A33 – 1st Floor Green Wing Hallway

Sample ID: A33 **Sample Location: 1st Floor – Green Wing Hallway**

Levels slightly higher than baseline of *Stachybotrys* were present in this sample. Spore counts and volumes indicated a source of fungal amplification of this genus in this location.

Low levels of *Ascospores*, *Cladosporium*, *Myxomycetes*, and *Pithomyces* were also present in this sample. Spore counts and volumes were low and did not indicate a source of fungal amplification of these genera in this location.

EnviroMed Services identified a source of airborne fungal amplification of the toxigenic mold *Stachybotrys* in the 1st Floor Green Wing Hallway of the school.

EnviroMed Services recommends that a professional remediation contractor clean all cleanable nonporous surfaces with a disinfecting agent such as Fiberlock ShockWave or equivalent in the affected area of the 1st Floor Green Wing Hallway of the school. In addition, EnviroMed recommends the use of an air scrubbing system to remove all airborne spores. We recommend the use of a HEPA (High-Efficiency Particulate Air) vacuum. Prior to cleaning, a Negative Air Pressure Containment setup will be required to prevent the contamination of any airborne mold spores during the remediation process. Containment air to be exhausted outside containment area during remediation. The HEPA Sandwich method (vacuum/ clean/ vacuum) is recommended with the continued use of an industrial HEPA Air Unit for at least 24 hours' post abatement work to further clean the air.

Following the cleaning, EnviroMed recommends a follow-up microbial assessment be performed by a professional industrial hygienist to verify the effectiveness of the cleaning.

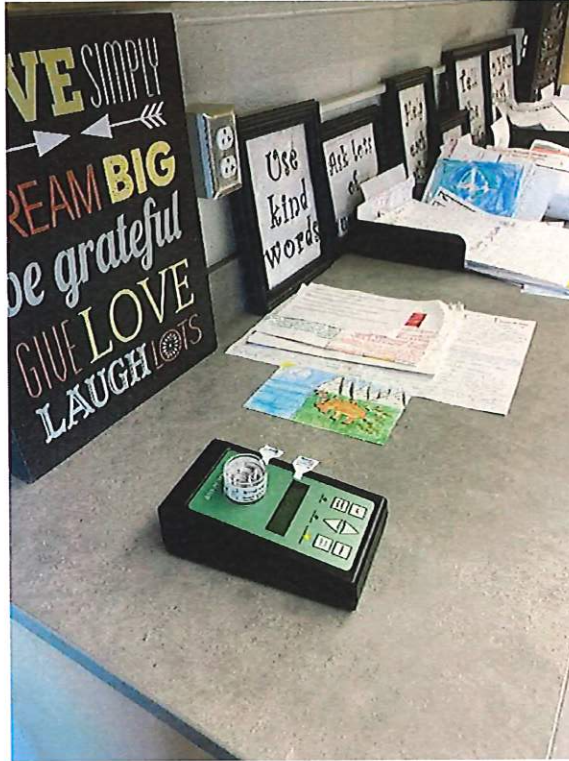
Figure 23. Location of Air Sample A34 – 2nd Floor Blue Wing Classroom B28

Sample ID: A34 **Sample Location: 2nd Floor – Blue Wing Classroom B28**

Low levels of *Ascospores* were present in this sample. Spore counts and volumes were low and did not indicate a source of fungal amplification of this genus in this location.

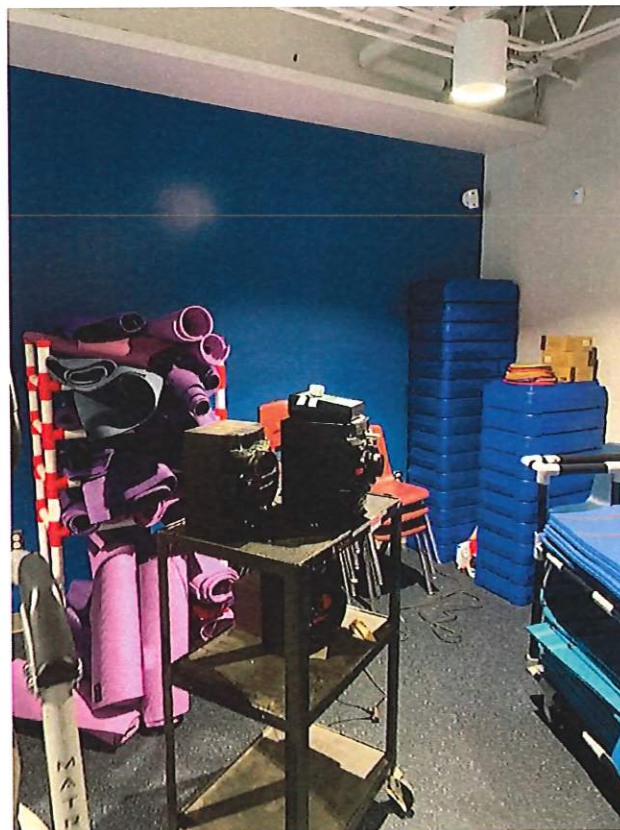
Figure 24. Location of Air Sample A35 – Cardio Room

Sample ID: A35 **Sample Location: 1st Floor – Cafe/Gym Wing, Cardio Room**

Low levels of *Basidiospores* and *Cladosporium* were present in this sample. Spore counts and volumes were low and did not indicate a source of fungal amplification of these genera in this location.

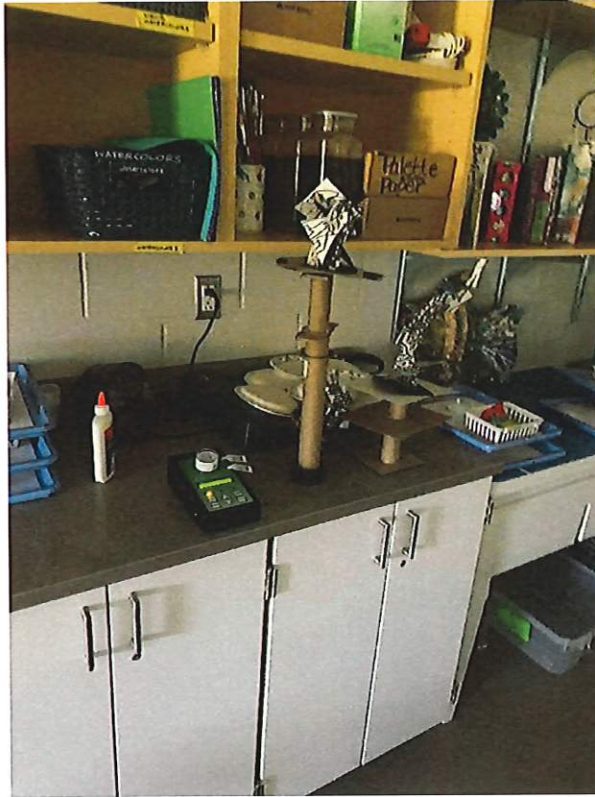
Figure 25. Location of Air Sample A36 – Art Room A037

Sample ID: A36 **Sample Location: 1st Floor – Black Wing Art Room 037**

Low levels of *Ascospores*, *Myxomycetes*, and *Pithomyces* were present in this sample. Spore counts and volumes were low and did not indicate a source of fungal amplification of these genera in this location.

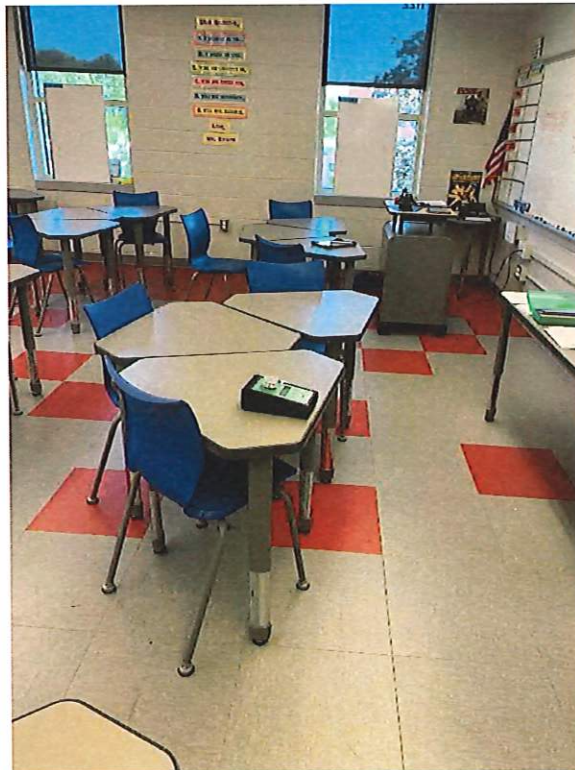
Figure 26. Location of Air Sample A37 – Classroom R22

Sample ID: A37 **Sample Location: 2nd Floor – Red Wing Room R22**

Low levels of *Ascospores* were present in this sample. Spore counts and volumes were low and did not indicate a source of fungal amplification of this genus in this location.

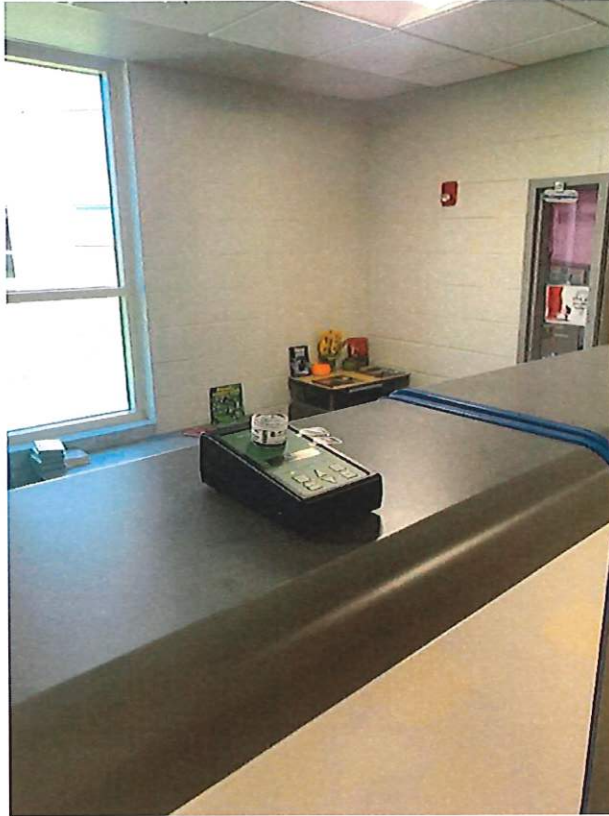
*Figure 27. Location of Air Sample
A38 – 1st Floor Yellow Wing Hallway*

Sample ID: A38 **Sample Location: 1st Floor – Yellow Wing Hallway**

Low levels of *Ascospores*, *Curvularia*, *Epicoccum*, *Myxomycetes*, *Pithomyces*, and *Rusts/Smuts* were present in this sample. Spore counts and volumes were low and did not indicate a source of fungal amplification of these genera in this location.

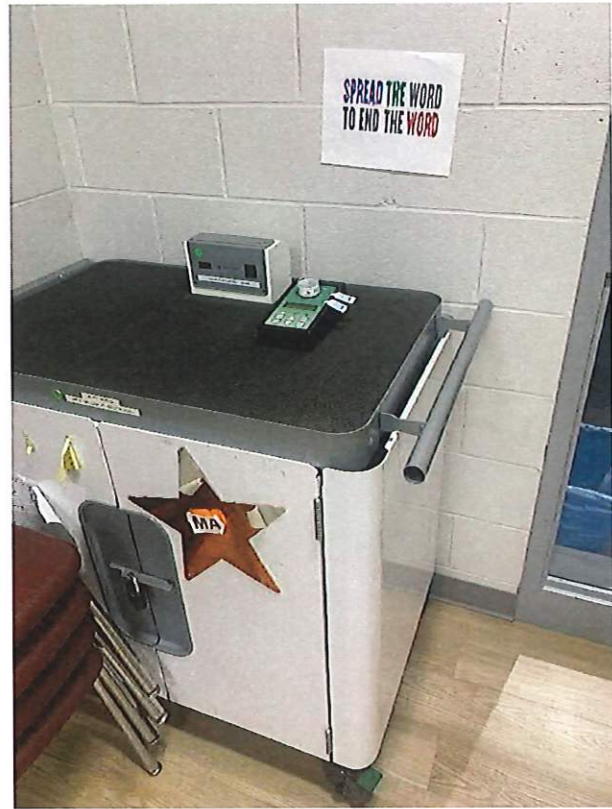
*Figure 28. Location of Air Sample
A39 – 1st Floor Café/Lounge*

Sample ID: A39

Sample Location: 1st Floor – Gym/Café Wing, Café Lounge

Low levels of *Bipolaris*/*Drechslera*, *Myxomycetes*, and *Pithomyces* were present in this sample. Spore counts and volumes were low and did not indicate a source of fungal amplification of these genera in this location.

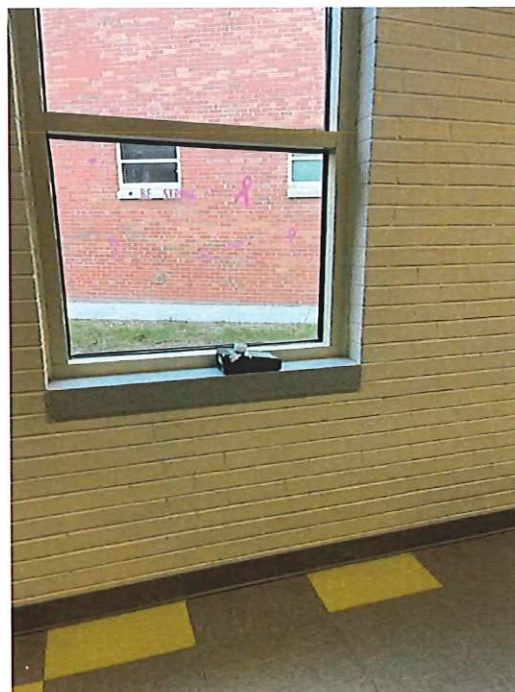
*Figure 29. Green Wing Hallway and location
of clearance sample A4. Figure from re-test
taken on November 7, 2023.*

Sample Location: Green Wing Hallway

Low levels of *Ascospores*, and *Cladosporium* were present in this sample. Spore counts and volumes were low and did not indicate a source of fungal amplification of these genera in this location.

There were no longer sources of fungal amplification or active mold growth in the Green Wing Hallway at John F. Kennedy Middle School. This hallway is fit for occupancy as there was no other evidence of mold contamination or presence of toxigenic mold.
