Fred Gerber Deputy Director, Enfield Public Works Re: Mold and Indoor Air Quality Results Enfield High School December 6, 2023

Baseline Indoor Air Quality Report For

Enfield High School 1264 Enfield Street Enfield, CT 06082

EnviroMed Project # IH-23-1377

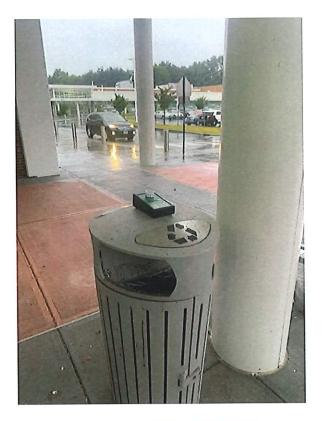
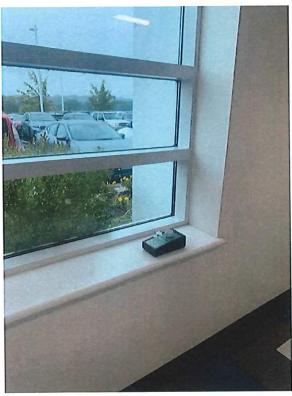
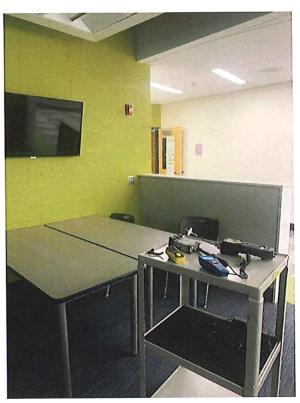
- On Day 1, LL. Automotive Classroom was found to contain significant amplification of Cladosporium. These noted molds were not detected in any other sample locations during the testing period.
 - This represents an unacceptable finding requiring mold remediation of this area in the school facility.
- The detected formaldehyde concentrations were well below the OSHA PEL of 0.75 ppm.

- On September 18, 2023, LL. Automotive Classroom was found to contain significant amplification of Cladosporium. These noted molds were not detected in any other sample locations during that testing period.
 - This represented an unacceptable finding requiring mold remediation of this area in the school facility.
- On November 7, 2023, the airborne spore trap results inside the Automotive Classroom were overall similar to those levels and types of molds found in the outside air from the baseline.

Figure 1. A1 Exterior Baseline (Top Left), A2 Automotive Classroom (Top Right), A3 Wing Exit Near Paring Lot (Bottom Left) and A4 E Wing Common Area (Bottom Right).

EnviroMed Services recommends that a professional remediation contractor clean all cleanable nonporous surfaces with a disinfecting agent such as Fiberlock ShockWave or equivalent in the affected area of the LL. Automotive Classroom, in addition, EnviroMed Services, Inc. recommends the use of an air scrubbing system to remove all airborne spores. We also recommend the use of a HEPA (High-Efficiency Particulate Air) vacuum. Prior to cleaning, a Negative Air Pressure Containment setup will be required to prevent the contamination of any airborne mold spores during the remediation process. Containment air to be exhausted outside containment area during remediation. The HEPA Sandwich method (vacuum/ clean/ vacuum) is recommended with the continued use of an industrial HEPA Air Unit for at least 24 hours' post abatement work to further clean the air.

Following the cleaning, EnviroMed recommends a follow-up microbial assessment be performed by a professional industrial hygienist to verify the effectiveness of the cleaning.
